**Final Postflight Hardware Evaluation Report  
RSRM-32 (STS-57)**

**November 1993**

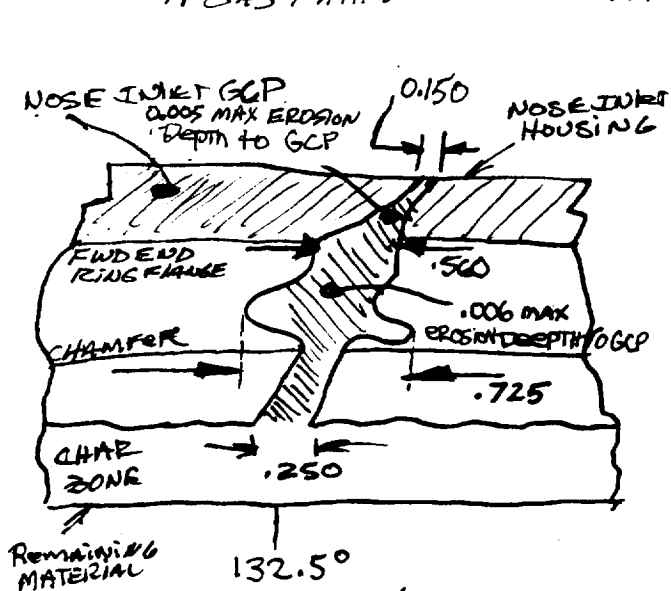
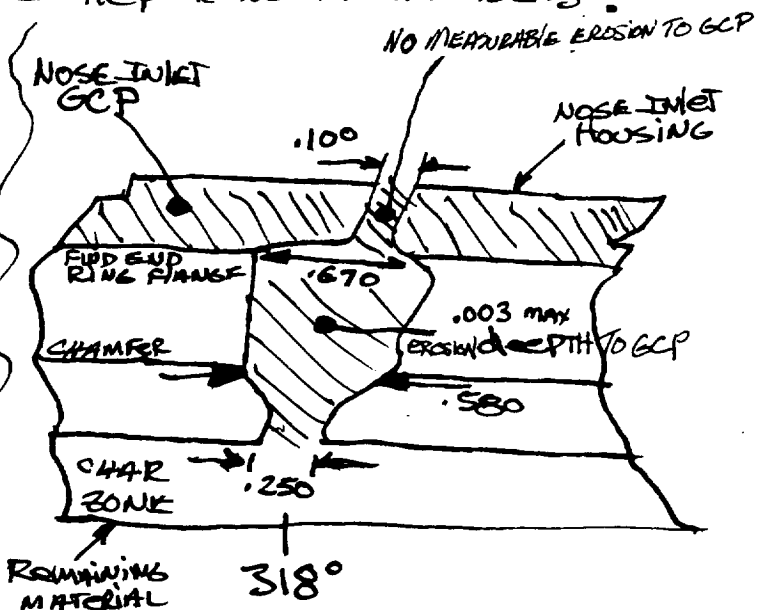
Special Issue 3.3.5

**Results:** A gas path was observed at 132 degrees at the RTV repair. Soot entered the joint and extended to the primary O-ring at 108-to-150-degrees. Charred CCP, GCP and SCP were observed below the char line. Eroded GCP was observed with a maximum depth of 0.006 inch. Heat affected paint was present on forward end ring flange OD. This was the first joint to have a RTV repair.

A GAS PATH WAS FOUND AT CDI REPAIR LOCATION AT 132.5°.

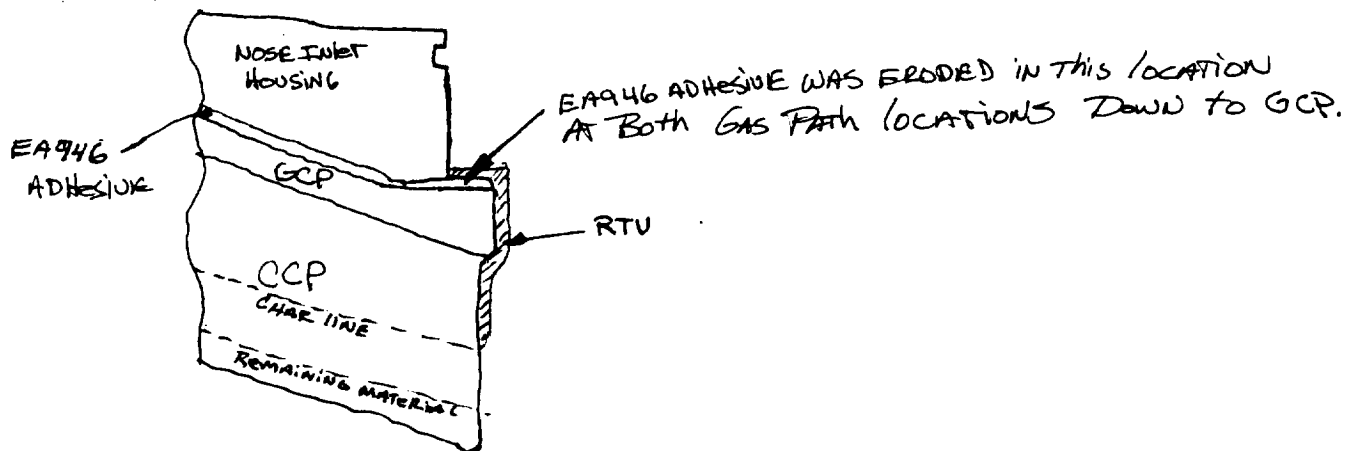
- NOSE INLET
- (1) RTV COVERED BONDLINE BETWEEN PHENOLICS AND HOUSING, AREAS WHERE RTV WAS REMOVED SHOWED NO EDGE SEPS. NO EDGE SEPS. FOUND ON COWL BONDLINE.
- (2) HEAT AFFECTED SCP, CCP AND GCP IN LINE WITH GAS PATHS AT 132.5° AND 318°. SLIGHT EROSION WAS EVIDENT ON THE GCP, SCP AND CCP. APPROX DEPTHS ON THE GCP ARE SHOWN IN SKETCHES ON PFOR A-8.

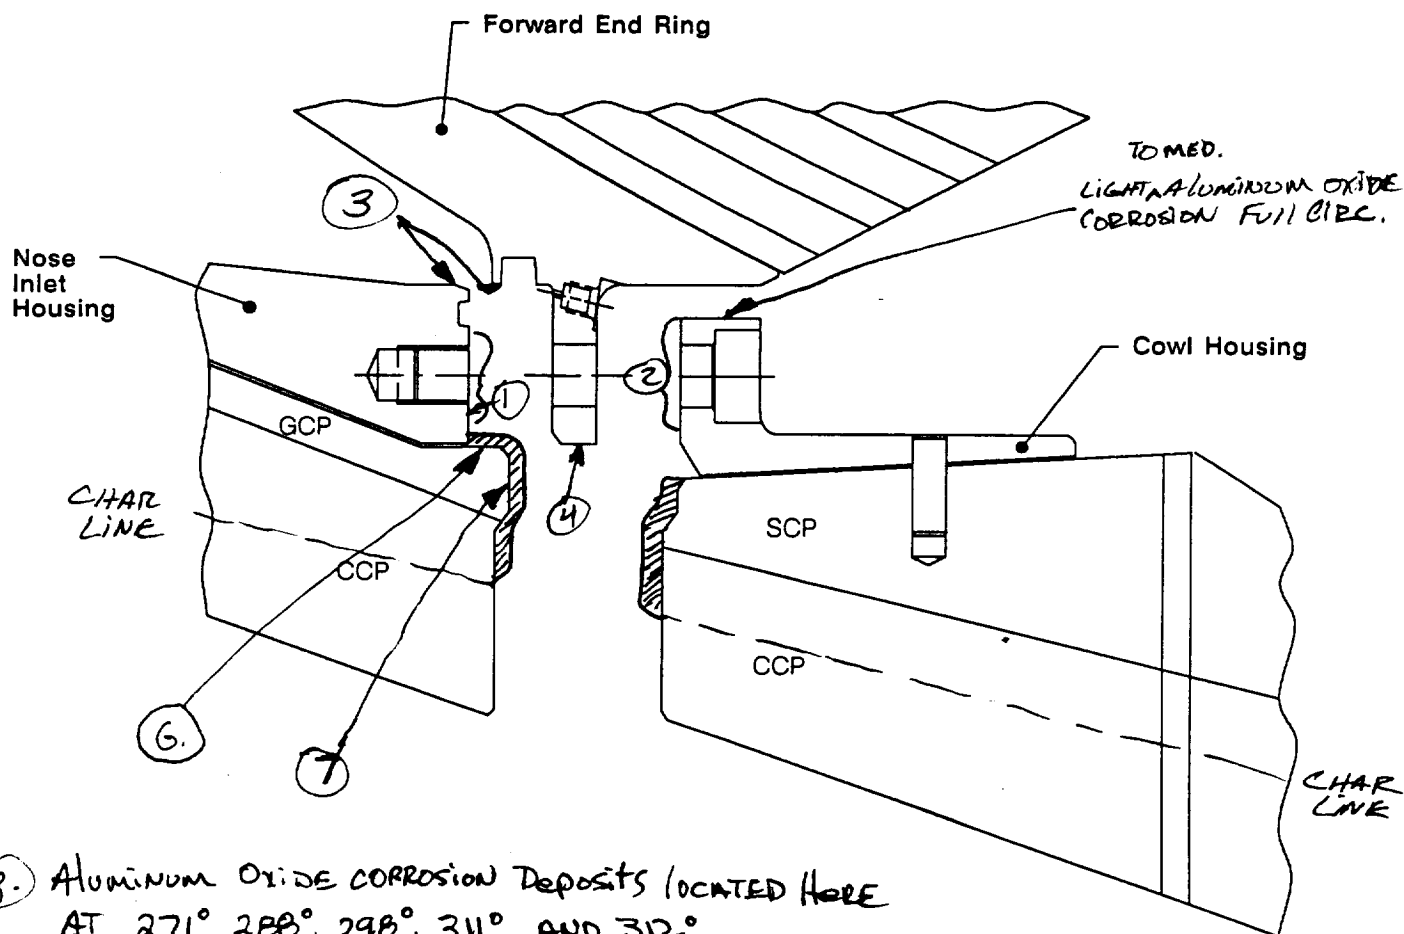
POSTFLIGHT OBSERVATION RECORD (PFOR)  
Nozzle Internal Joint O-rings (Detailed) - Joint 2

One anomalous condition was observed. Typical scalloped shaped soot was observed to the bolt hole circle intermittently full circumference. Soot reached the primary O-ring at two locations, 108-150 degrees and 306-330 degrees. Both locations corresponded to gas paths through the RTV. Preliminary PFAR 57C-01 was written on this condition. Soot did not go past the O-ring footprint. No O-ring or seal damage was observed. Traces of water were observed in the joint following demate.

The RTV backfill was below the char line over the full circumference to the nose inlet housing aft face. RTV did not reach the primary O-ring. Gas penetration into the joint was observed at 132.5 and 318 degrees. Heat affected paint, CCP and GCP/SCP was observed in the joint. Eroded GCP and adhesive was present at the gas path locations.

- ① SOOT INTO JOINT SURFACE FROM GAS PATHS WITH INTERMITTENT FULL CIRCUMFERENCE LIGHT-MED. CORROSION.
- ② LIGHT TO MED CORROSION INT. FULL CIRCUMFERENCE.

- ③ ALUMINUM OXIDE CORROSION DEPOSITS LOCATED HERE AT 271°, 288°, 298°, 311°, AND 312°.
- ④ INTERMITTENT SOOTING FROM GAS PATHS, HEAT AFFECTED PAINT AT GAS PATH LOCATIONS.
- ⑤ GAS PATHS THROUGH RTV LOCATED AT 132.5° AND 318°. SOOT ENTERED JOINT AND REACHED PRIMARY O-RING AT 108°-150° AND 306°-330°.
- ⑥ EA946 ADHESIVE LOCATED ON THIS SURFACE WAS ERODED AWAY IN LINE WITH GAS PATH AT 132.5° (.025 inch THICKNESS EROSION). EA946 WAS ALSO ERODED TO GLASS CLOTH PHENOLIC AT 318° (.023 inch). GCP EROSION TO .005 DEPTH PRESENT AT 132.5°.
- ⑦ GLASS CLOTH-PHENOLIC EROSION IN THIS AREA 132.5° - 0.005 inch, 318° - 0.003 inch.

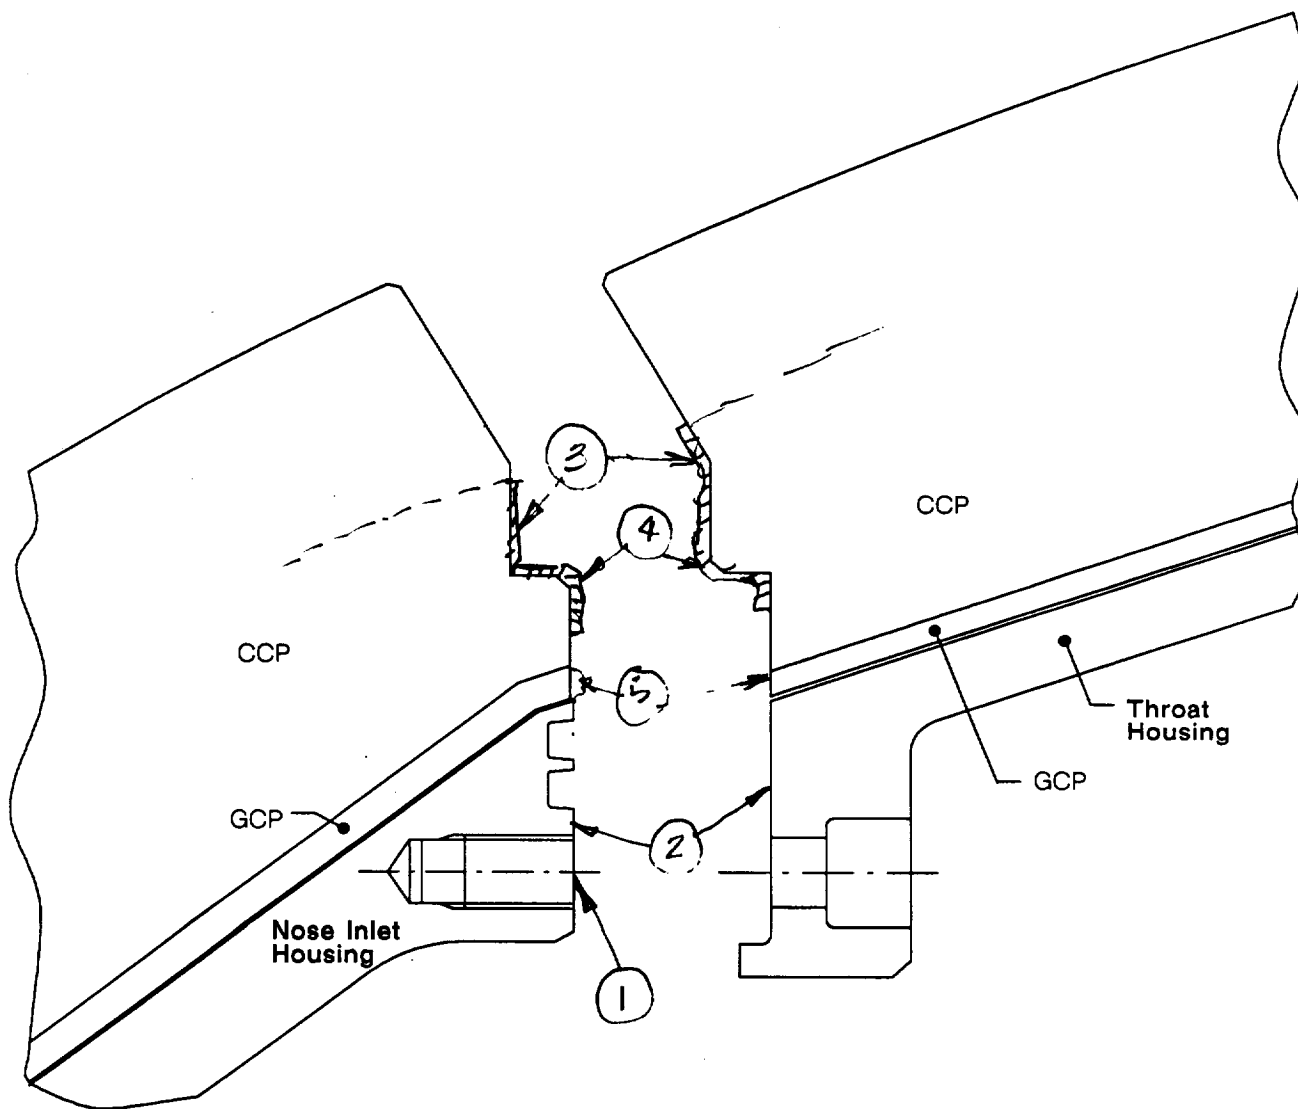
- ① NO EXCESS GREASE IN HOLES
- ② GREASE COVERAGE NOMINAL
- ③ RTV BELOW CHAR LINE 360°
- ④ RTV FROM 0°-75° & 180°-0°

- ⑤ APPEARS TO BE SALT DEPOSIT FULL CIRCUM

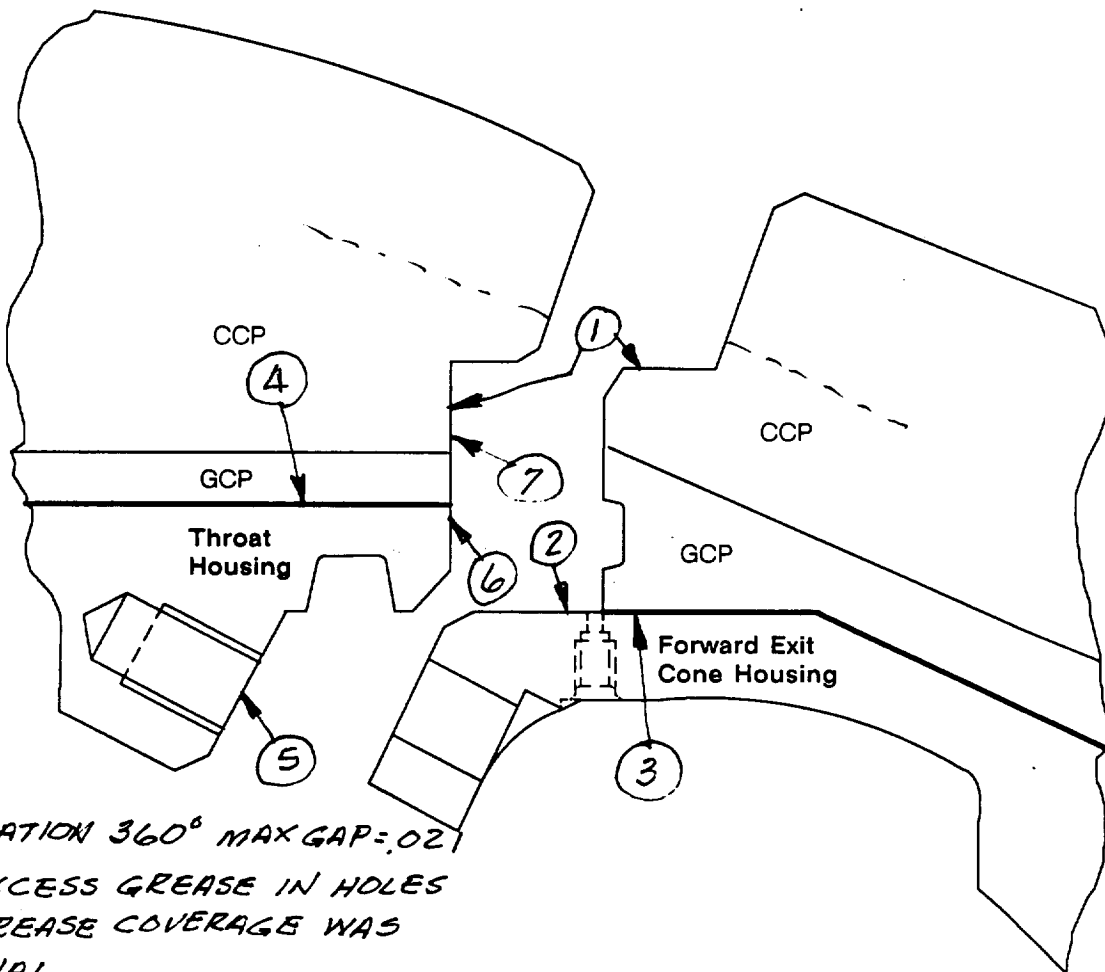
POSTFLIGHT OBSERVATION RECORD (PFOR)  
Nozzle Internal Joint O-rings (Detailed) - Joint 4

Light corrosion was observed on the forward exit cone housing secondary seal surface at 0-to-6 and 354 degrees. Medium-to-heavy corrosion observed on throat housing primary seal surface full circumference. This corrosion is splashdown related and is a nominal condition. No O-ring damage was observed.

- ① RTV TO PRIMARY O-RING INTERMITTENTLY 360°
- ② LIGHT CORROSION ON FWD EXIT CONE AT 354° & 0°-6°
- ③ SEPARATION INTERMITTENTLY 360° MAX = .015

- ④ SEPARATION 360° MAX GAP = .021
- ⑤ NO EXCESS GREASE IN HOLES AND GREASE COVERAGE WAS NOMINAL
- ⑥ MEDIUM TO HEAVY COVERAGE FULL CIRCUM
- ⑦ RTV DISCOLORED FROM SALT WATER FROM 345° THRU 0° TO 98°

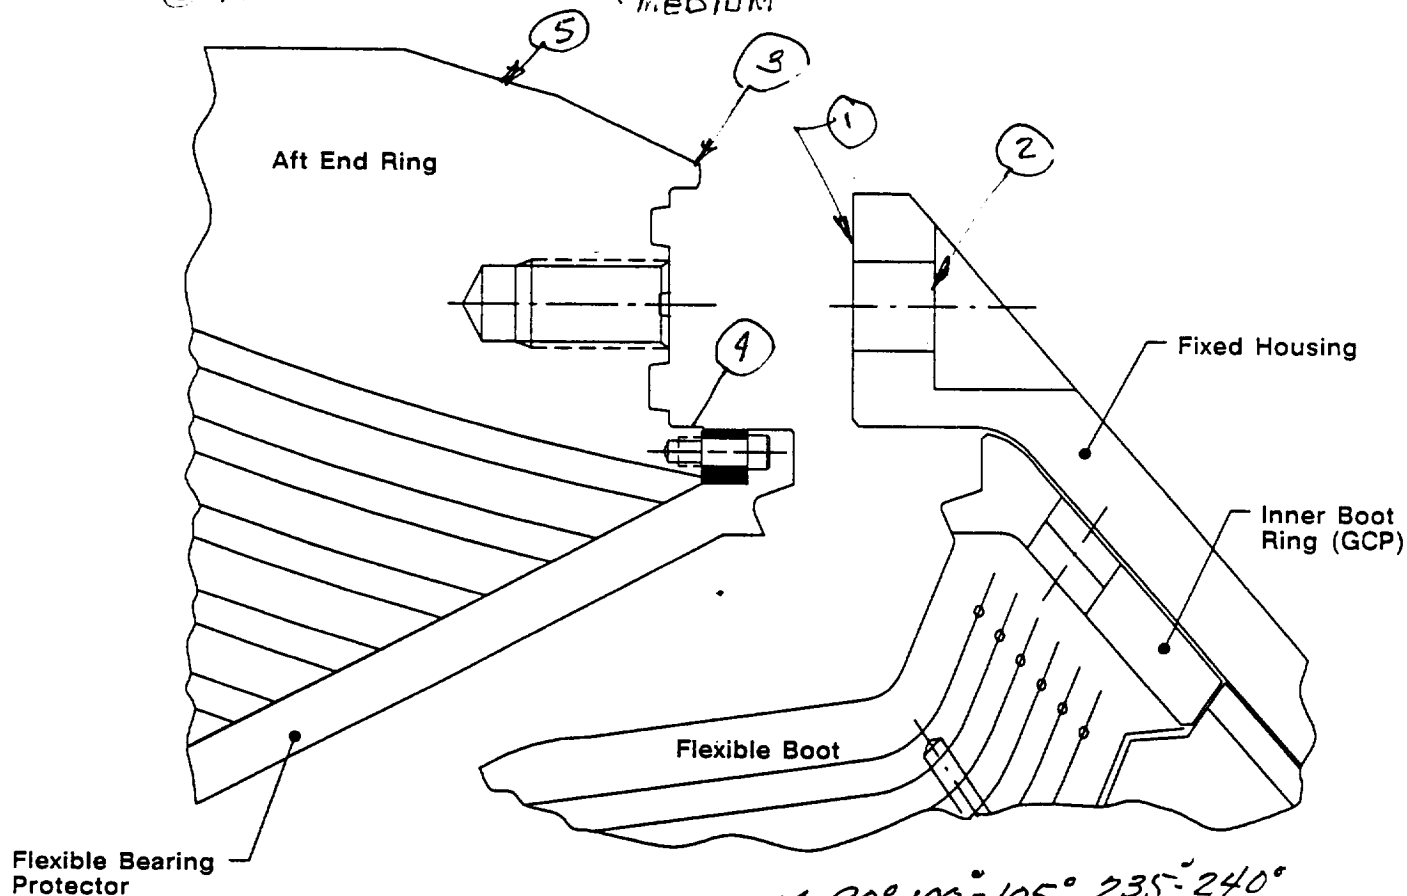
POSTFLIGHT OBSERVATION RECORD (PFOR)  
Nozzle Internal Joint O-rings (Detailed) - Joint 5

Light corrosion was observed on the fixed housing sealing surfaces at 110 degrees. Missing paint and corrosion was observed on the aft end ring flange lip at 260 through 265 degrees. Seventy-one of the seventy-two Packings-with-Retainers had typical disassembly damage to the elastomer. No seal surface damage was observed. No O-ring damage was observed.

- ① NOMINAL GREASE COVERAGE
- ② LIGHT CORROSION ON PACKING RING SEAL SURFACE AT 110°
- ③ MISSING PAINT AND CORROSION AT 260°-265° MEDIUM

- ④ RTV REACHED AER AT LOCATIONS 90°, 100°-105°, 235°-240° 248-295
- ⑤ SNUBBER CONTACT ON AER FROM 175-335 MAX AXIAL DISTANCE 6.2 IN.

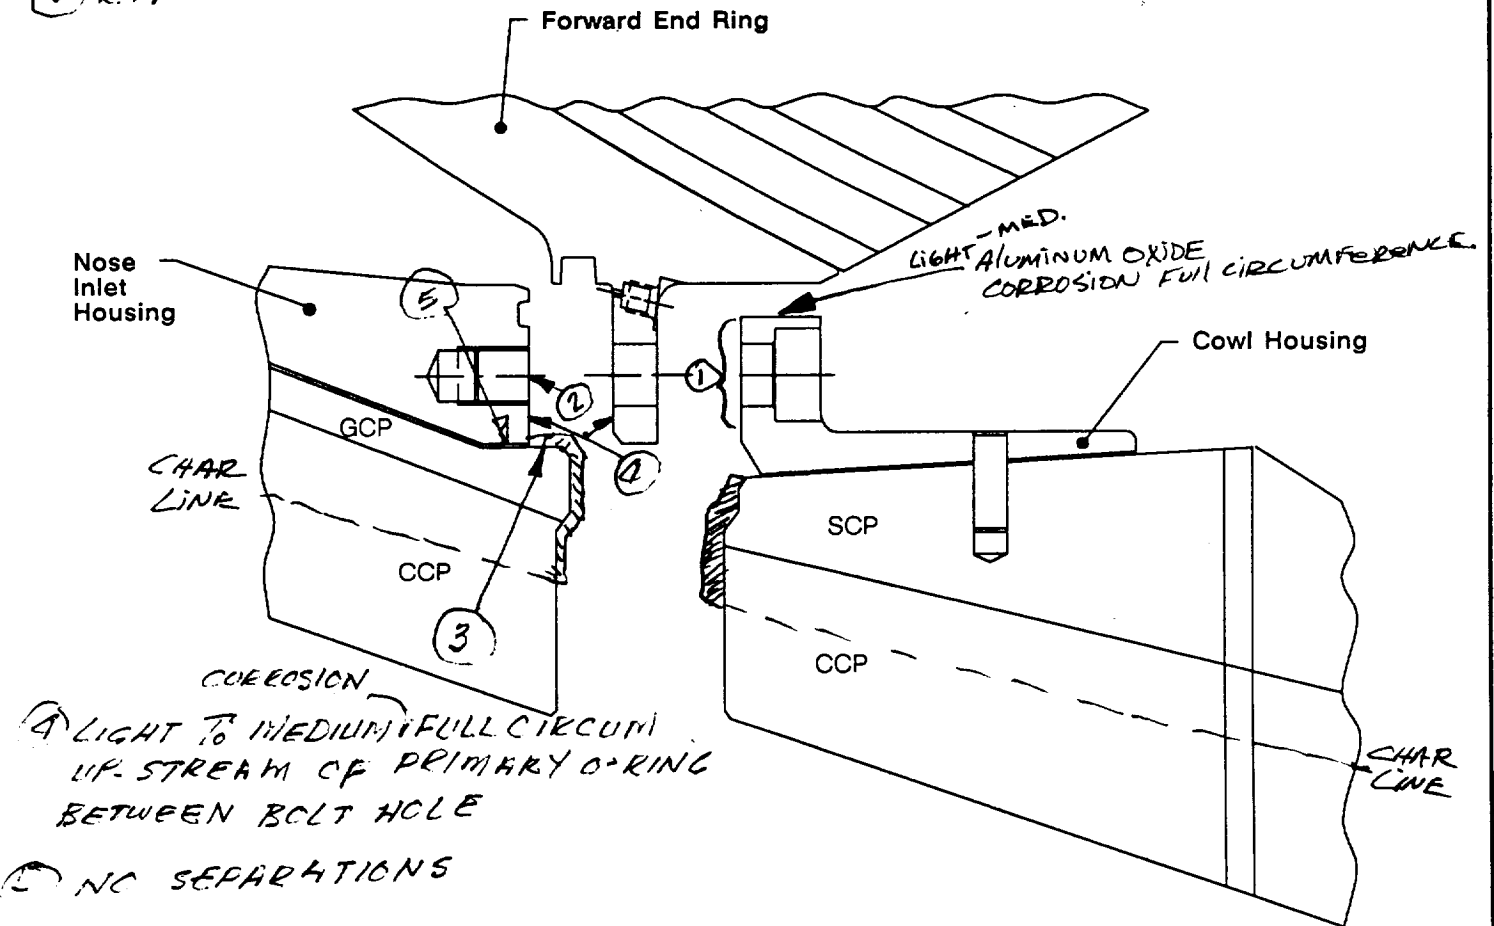
POSTFLIGHT OBSERVATION RECORD (PFOR)  
Nozzle Internal Joint O-rings (Detailed) - Joint 2

- ① INTERMITTENT LIGHT-MED CORROSION IN THIS AREA
- ② NO EXCESS GREASE IN BOLT HOLES
- ③ RTV TO INLET HSG FULL CIRCUM

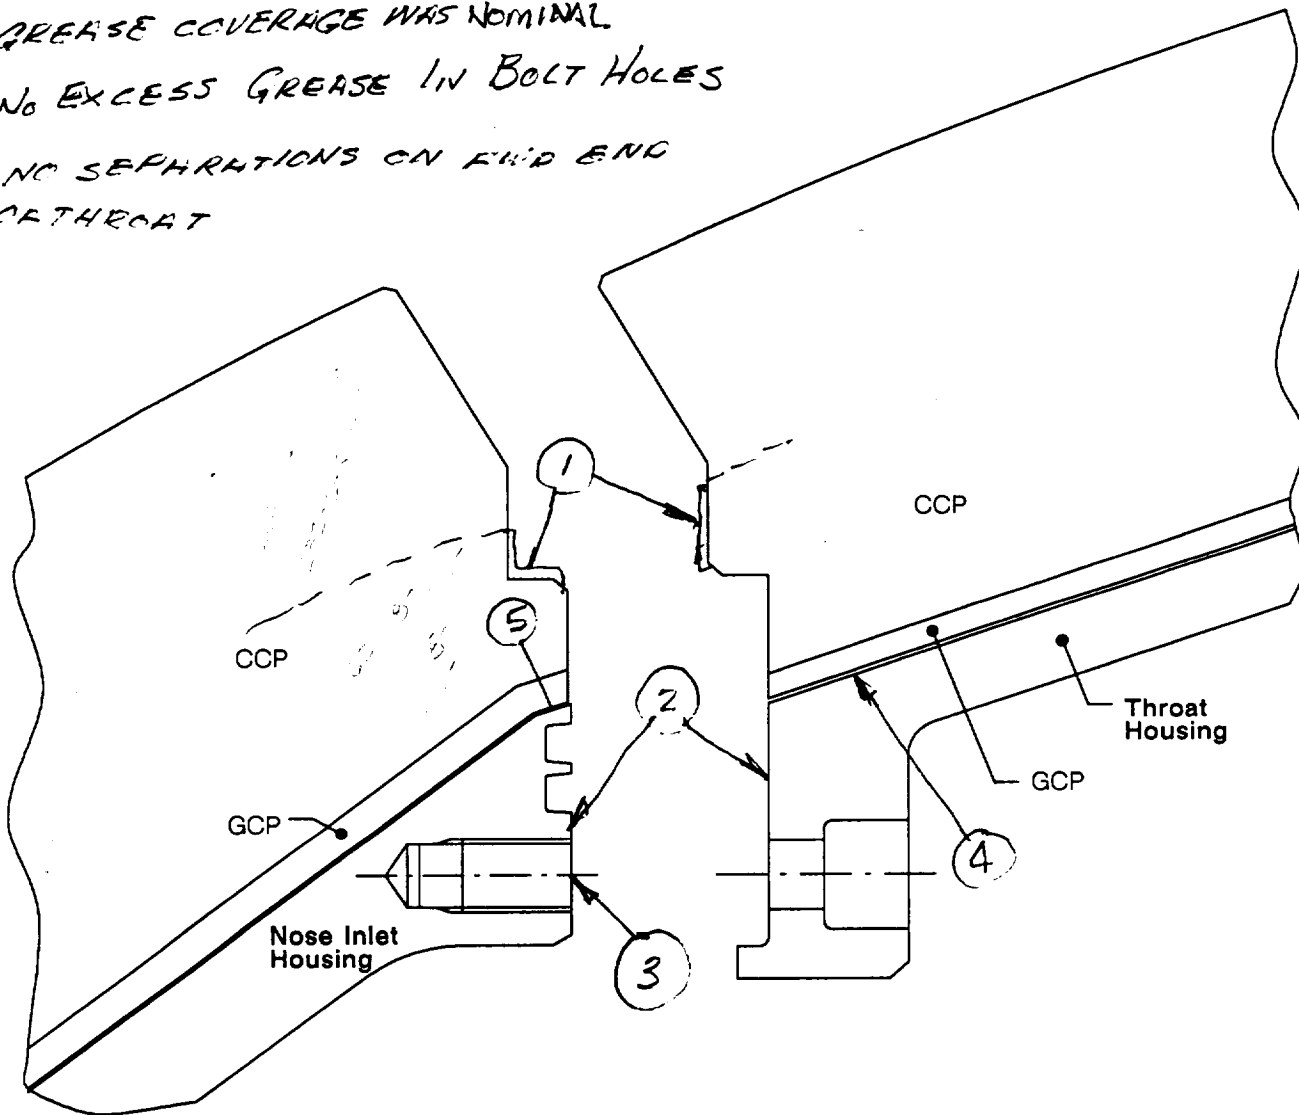
POSTFLIGHT OBSERVATION RECORD (PFOR)  
Nozzle Internal Joint O-rings (Detailed) - Joint 3

- ① RTV BELOW CHAR LINE FULL CIRCUM
- ② GREASE COVERAGE WAS NOMINAL
- ③ NO EXCESS GREASE IN BOLT HOLES
- ④ NO SEPARATIONS ON FWD END OF THROAT

- ⑤ SEPARATIONS BETWEEN INLET HSG AND AFT INLET RING  
AT 110°-157°=.005, 162°-187°=.005, 232°-245°=.005 AND  
300°-340°=.005

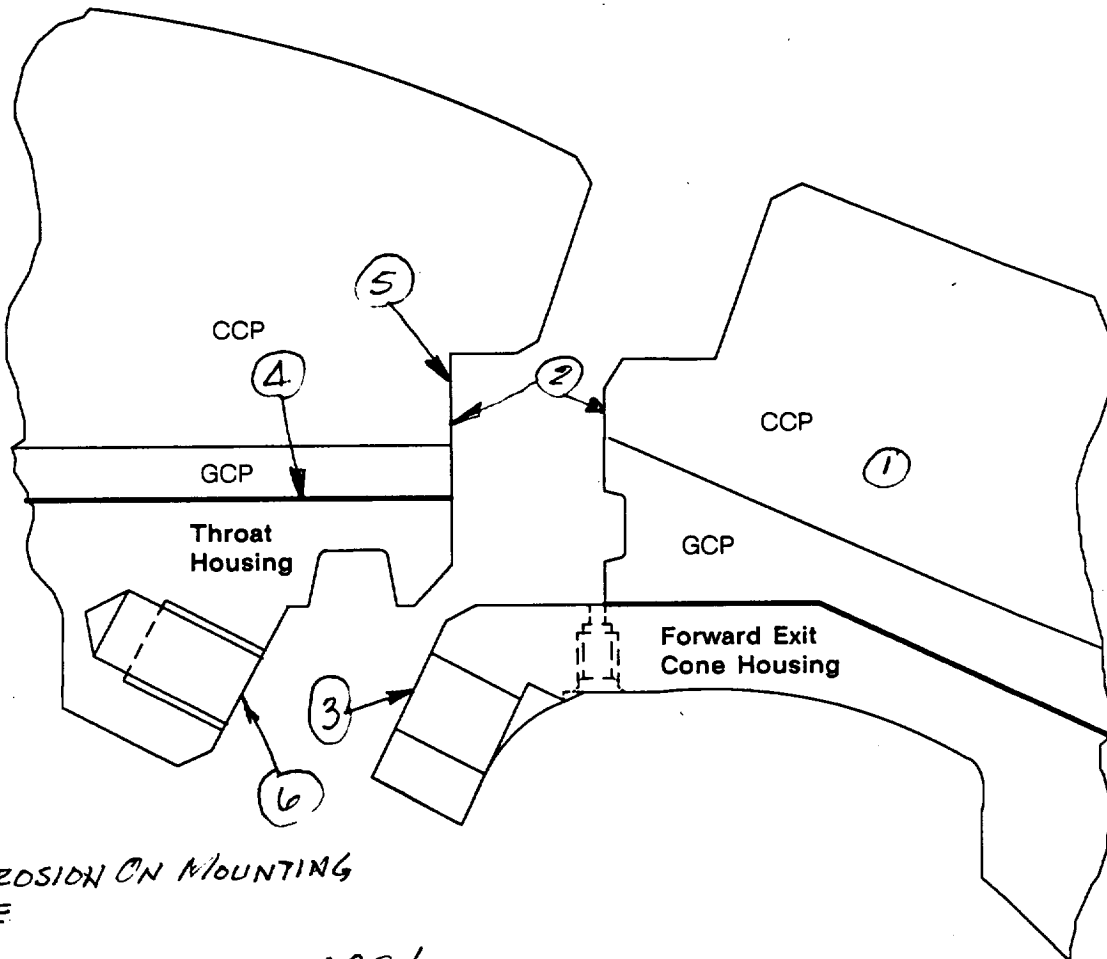
POSTFLIGHT OBSERVATION RECORD (PFOR)  
Nozzle Internal Joint O-rings (Detailed) - Joint 4

- ① ALL CARBON MISSING EXCEPT FROM 198°-265°
- ② RTV BELOW CHAR LINE FULL CIRCUM

- ③ NO CORROSION ON MOUNTING FLANGE
- ④ SEPARATION BETWEEN GCP & HOUSING FULL CIRCUM
- ⑤ RTV DISCOLORED FROM SEA WATER FROM 198°-265°
- ⑥ NO EXCESS GREASE IN HOLES

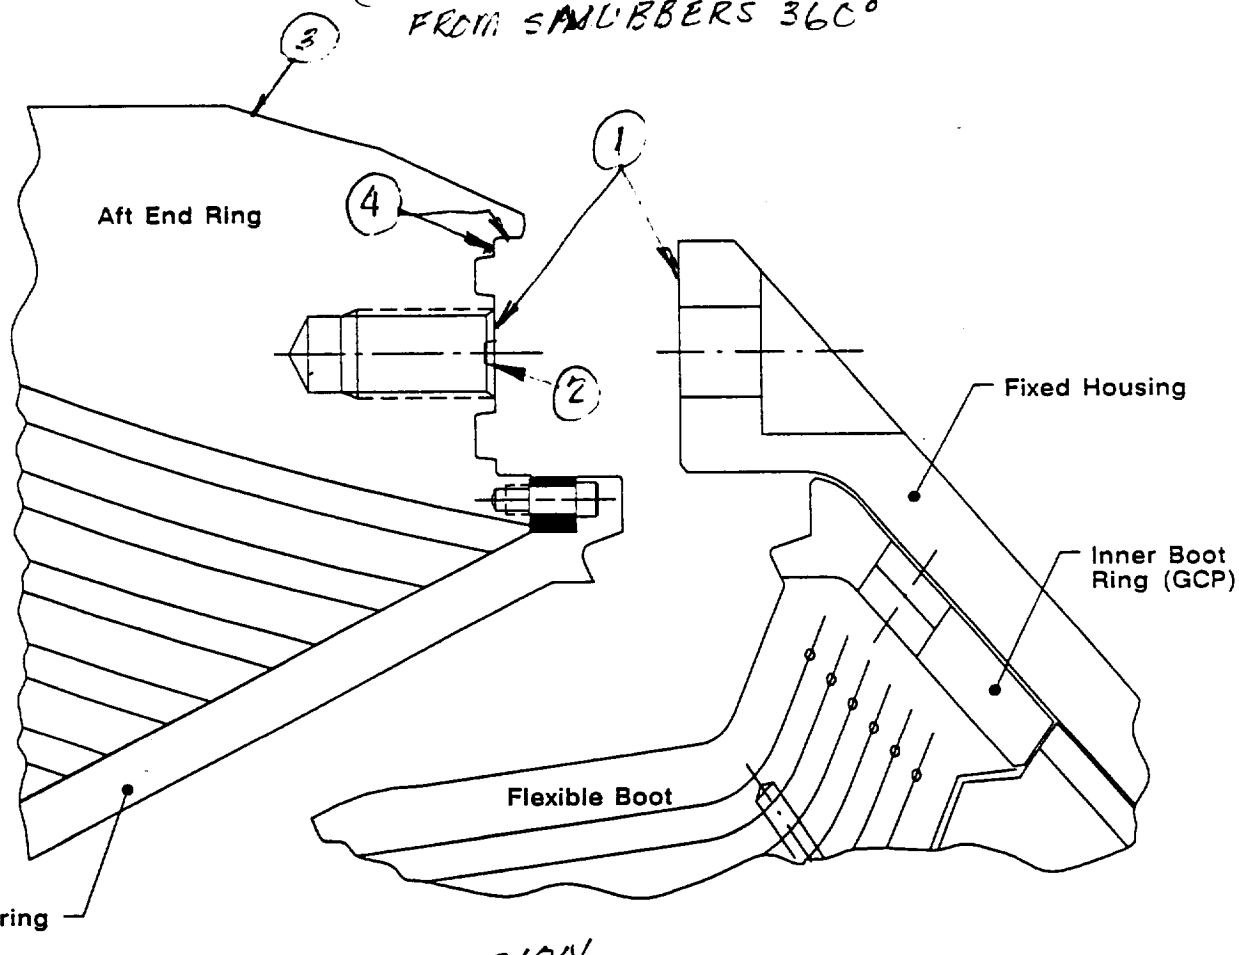
POSTFLIGHT OBSERVATION RECORD (PFOR)  
Nozzle Internal Joint O-rings (Detailed) - Joint 5

No anomalous conditions were observed. Medium-to-heavy corrosion observed on the aft end ring flange lip full circumference. All seventy-two Packings-with-Retainers had typical disassembly damage to the elastomer. No seal surface damage was observed. No O-ring damage was observed.

- ① NOMINAL GREASE COVERAGE
- ② NO EXCESS GREASE IN BOLT HOLES
- ③ LIGHT INTERMITTENT SCARFE MARKS FROM SANDERS 360°

- ④ MEDIUM TO HEAVY CORROSION INTERMITTENTLY FULL CIRCUM

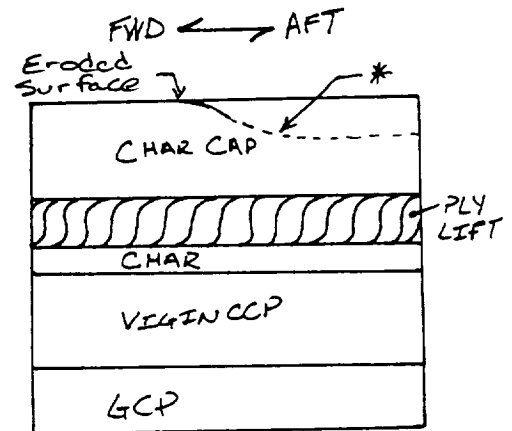
AEC PHENOLIC  
CROSS-SECTION

\* An increase in the amount of erosion was observed at approx. station 107.77 possible wash area intermittent around the circumference.

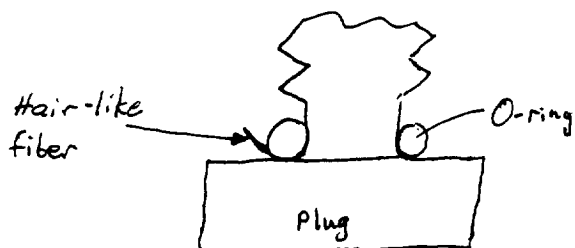
A hair-like fiber was found on the leak check plug shoulder seal (right side (B), 126 degrees). This fiber was photographed and removed for analysis. It was later determined by those present that this fiber was a result of disassembly

① Hairlike fiber found on Leak check plug Shoulder seal. Hair was removed. It was photographed before it was removed. No evidence to indicate that hair was in place before firing. (Hair-like fiber was a result of disassembly).
